Development of Test Methods for, and the Evaluation of, Miles Transducers

John D. Ramboz

Engineering Mechanics Section, Mechanics Division
Institute for Basic Standards
National Bureau of Standards
Washington, D. C. 20234

June 1976

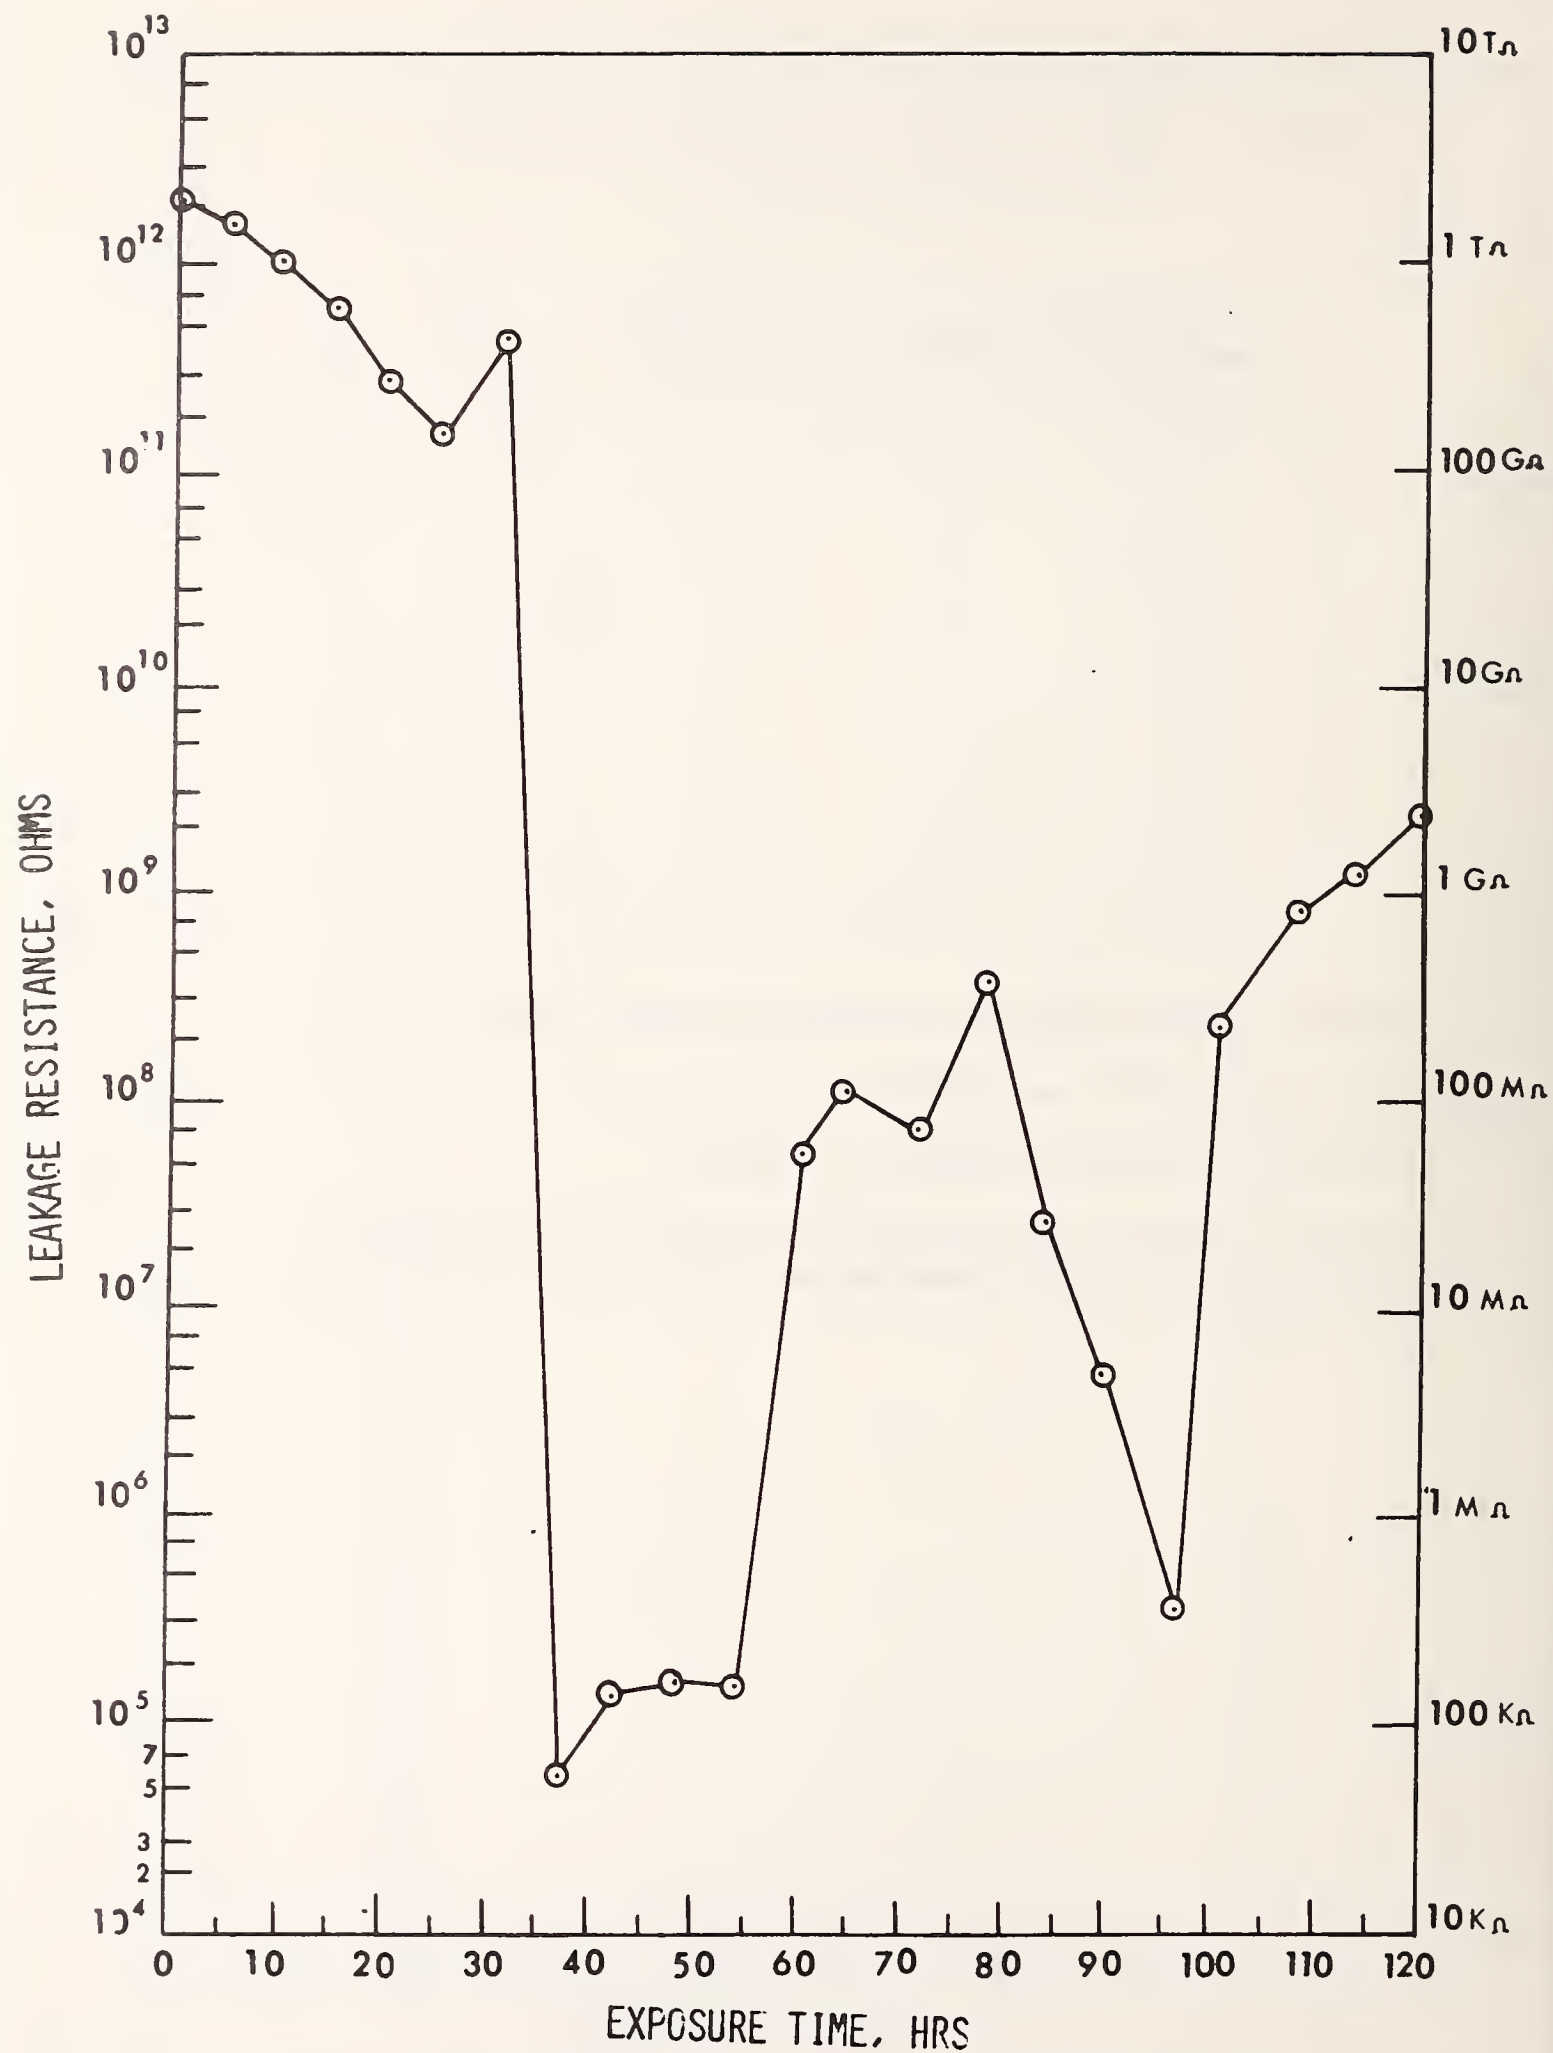
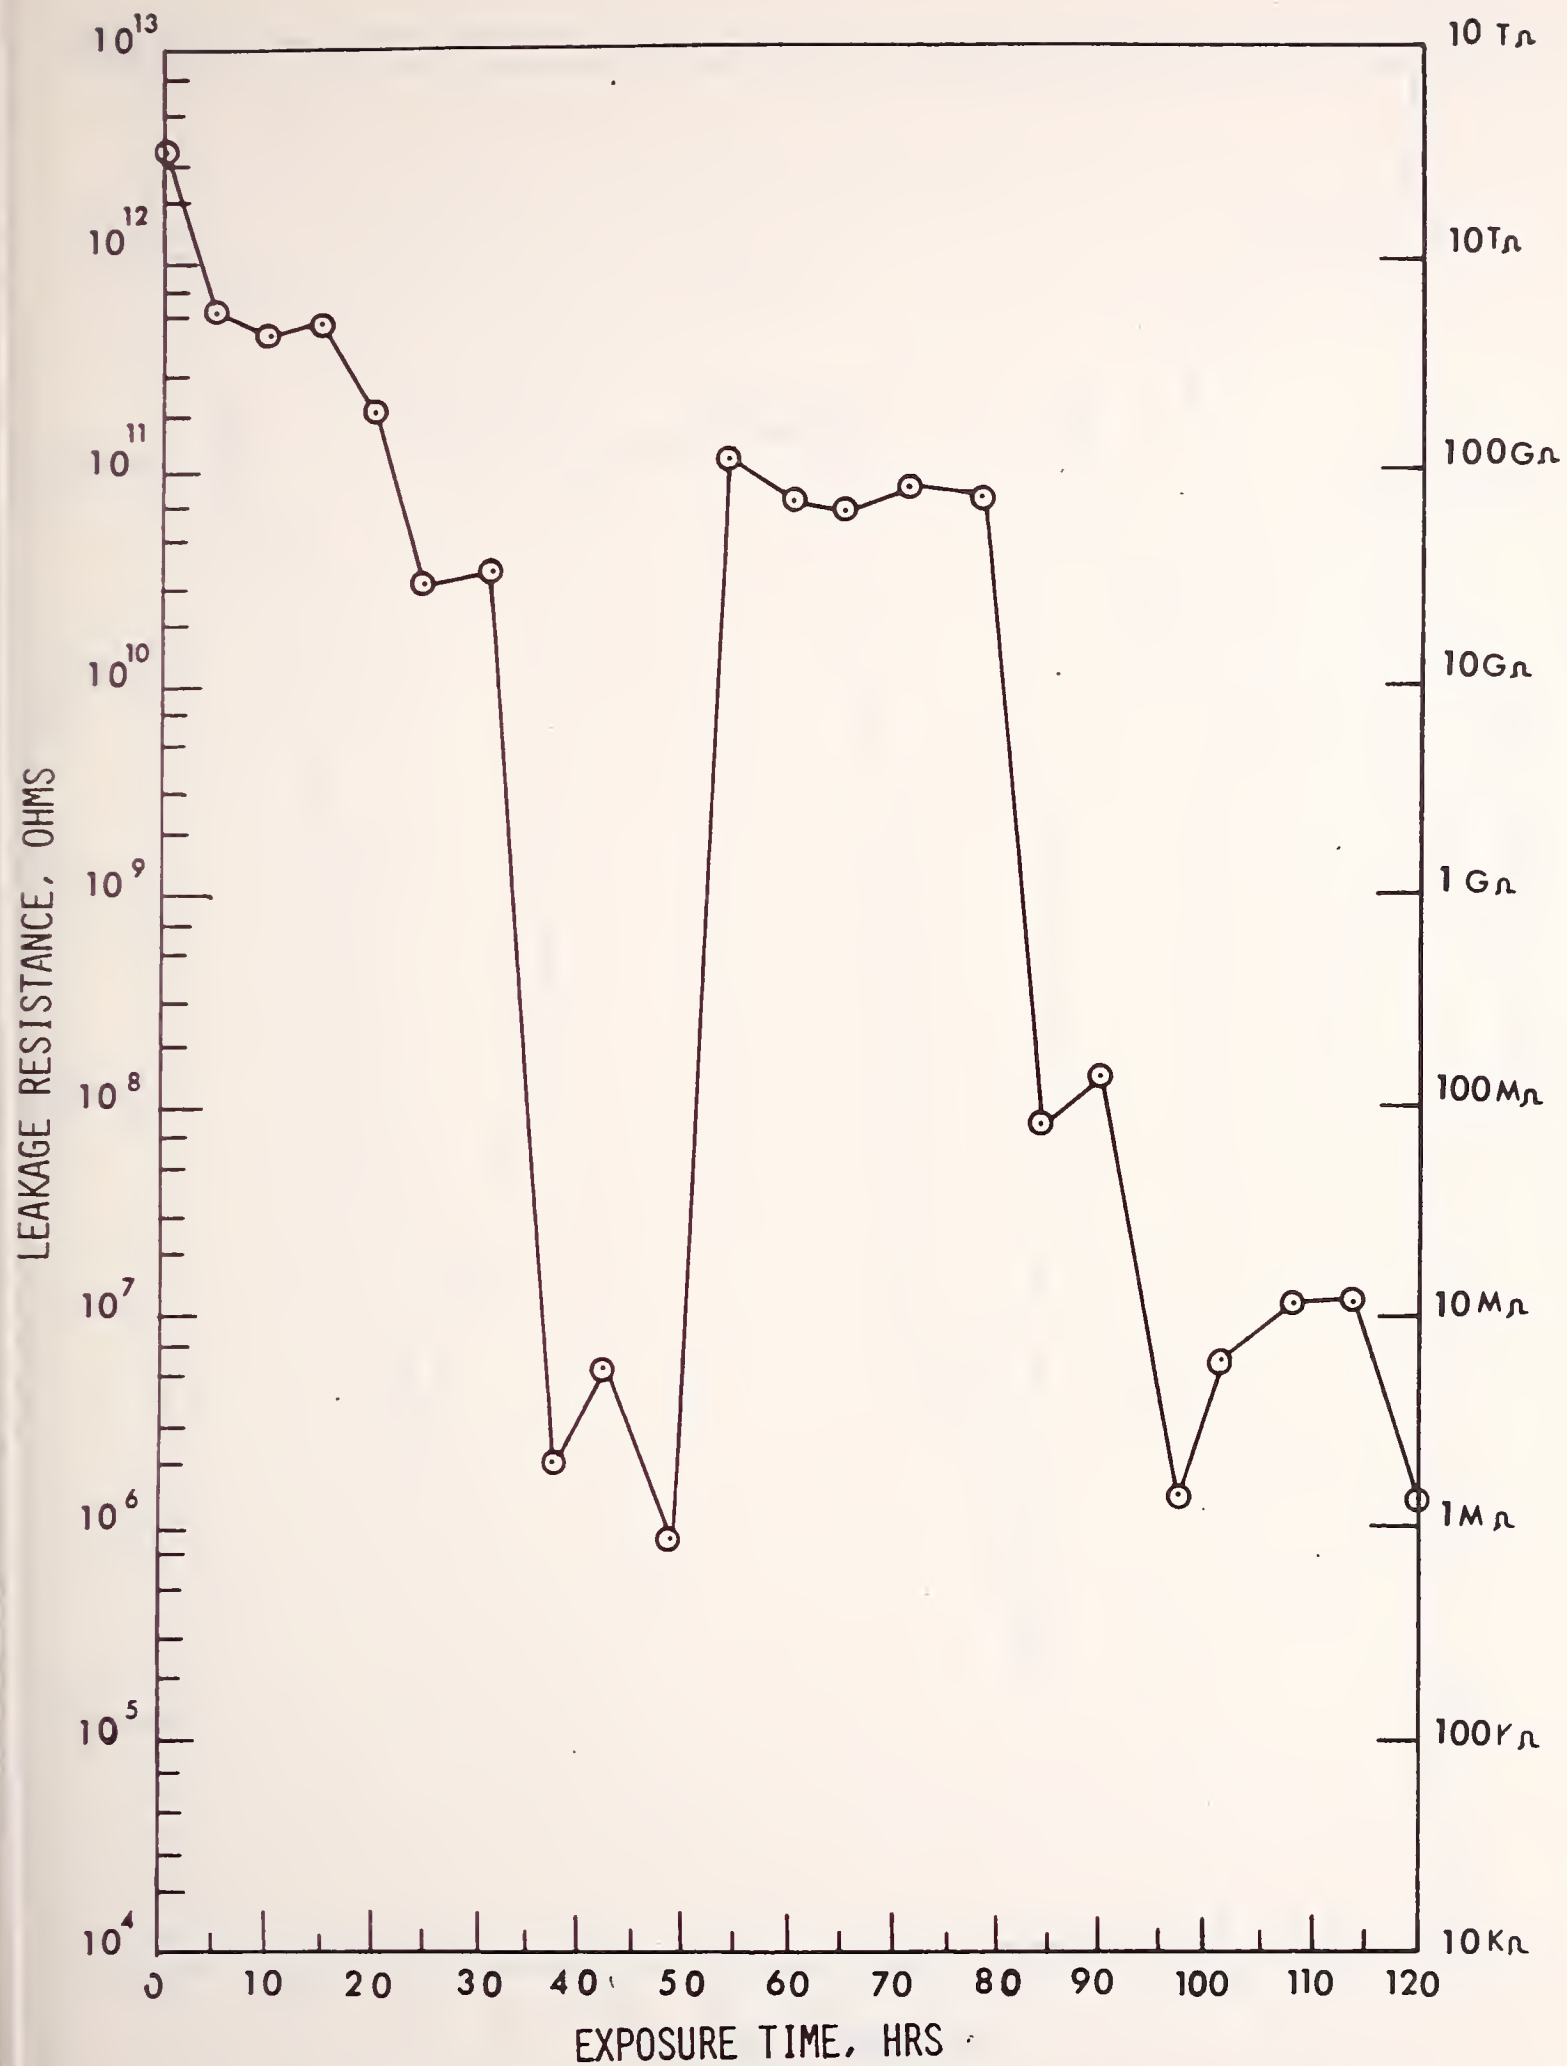
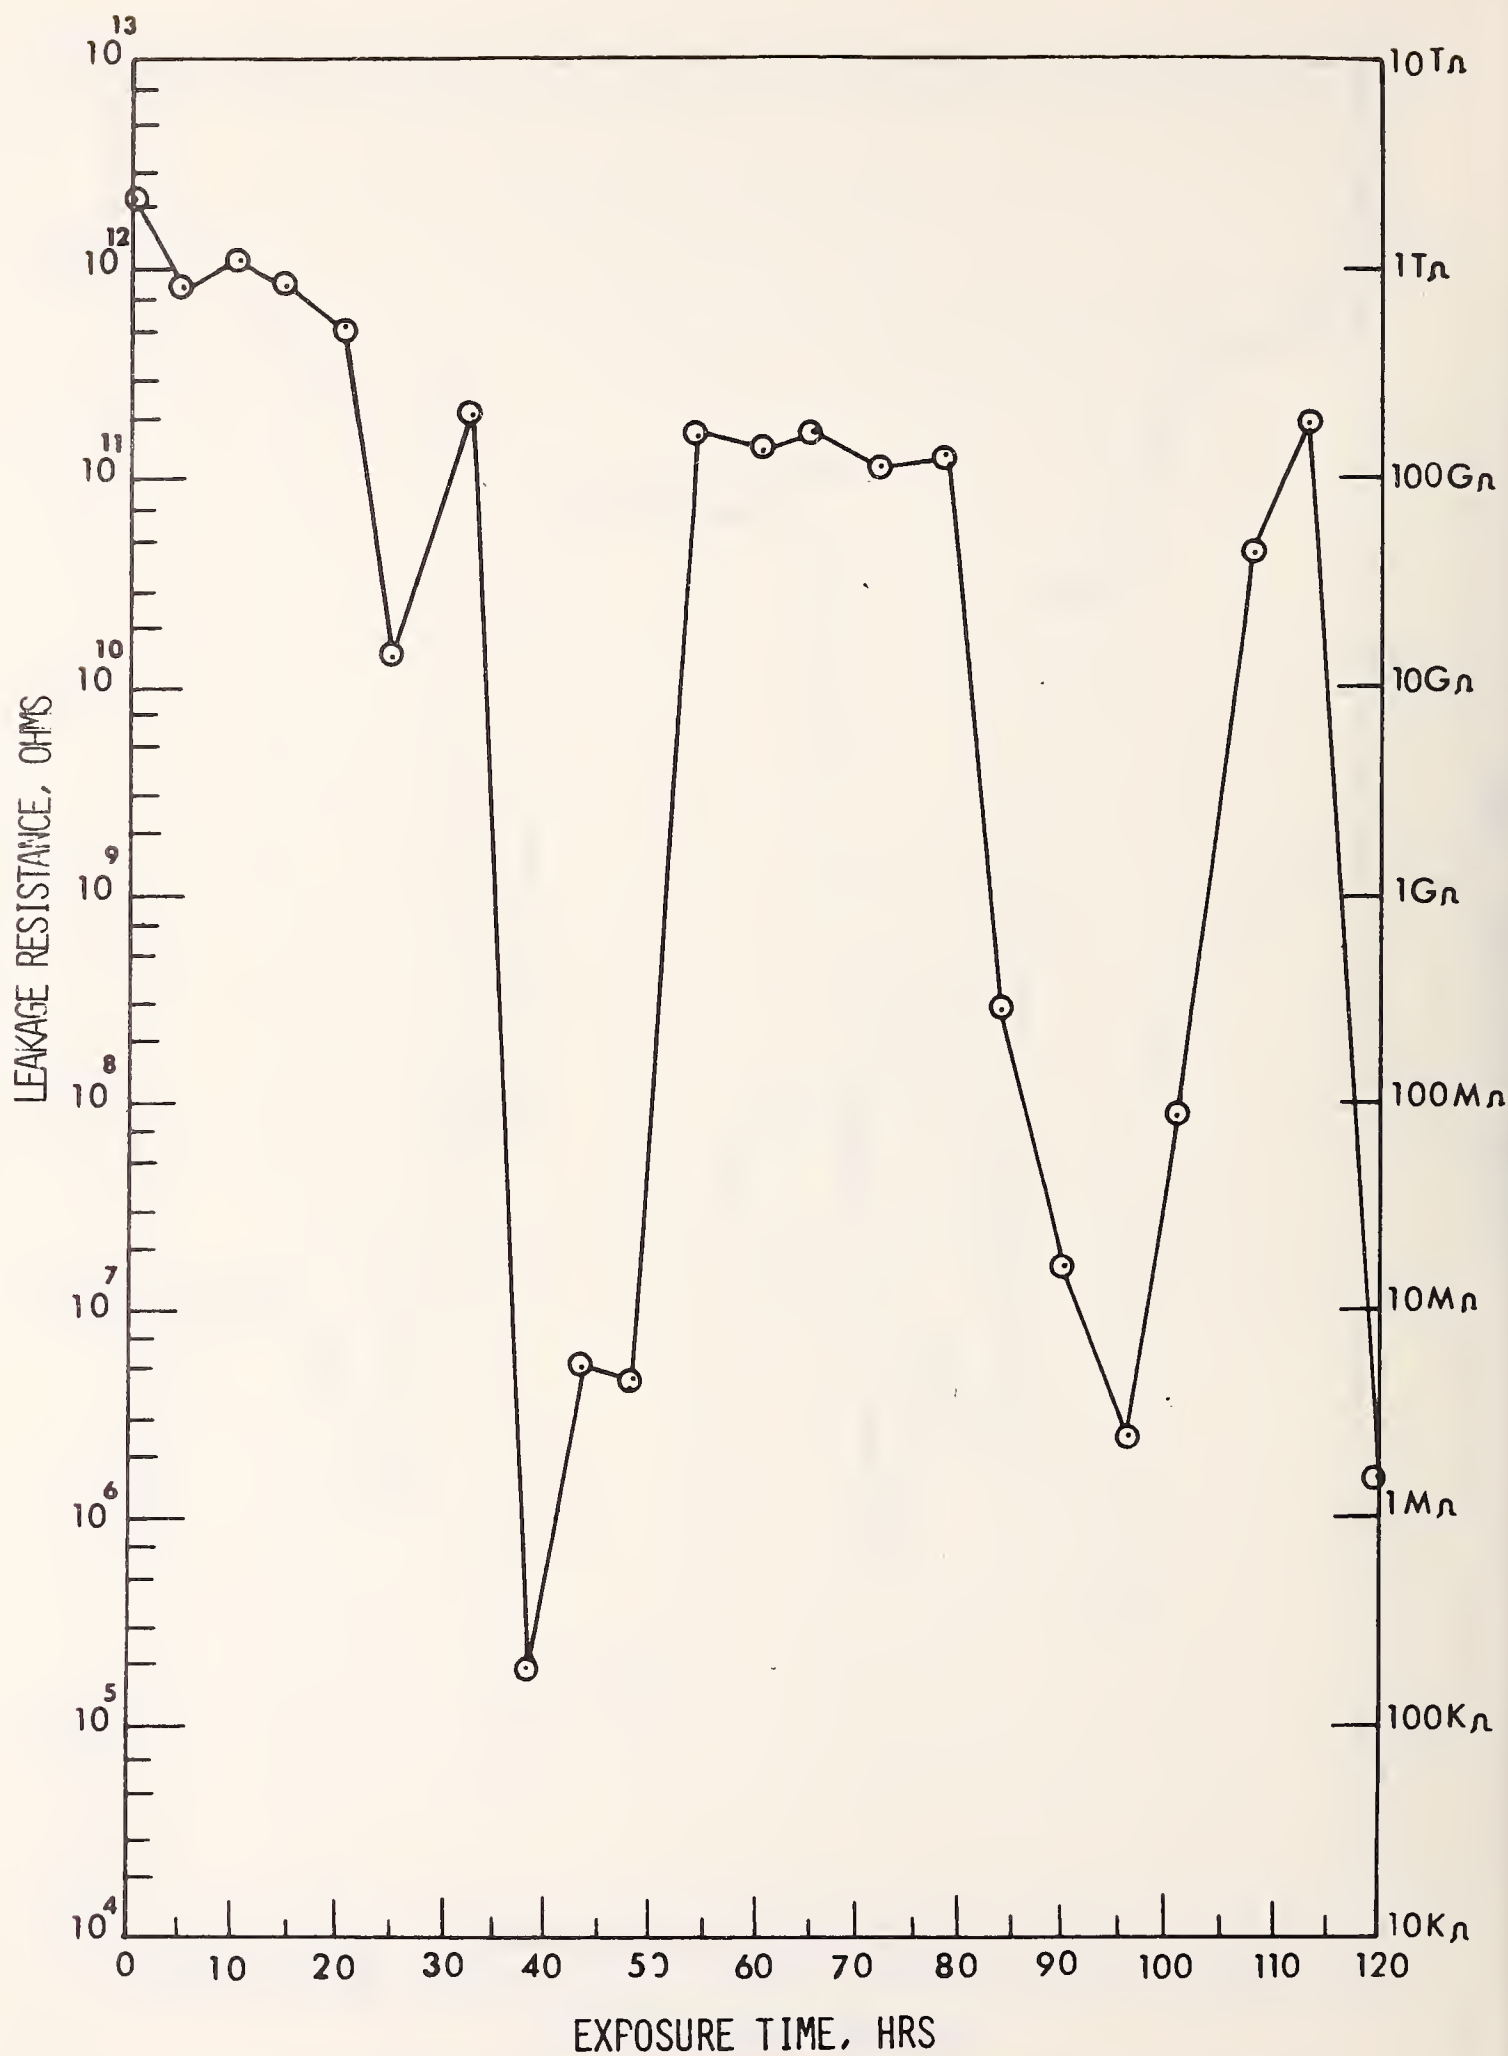
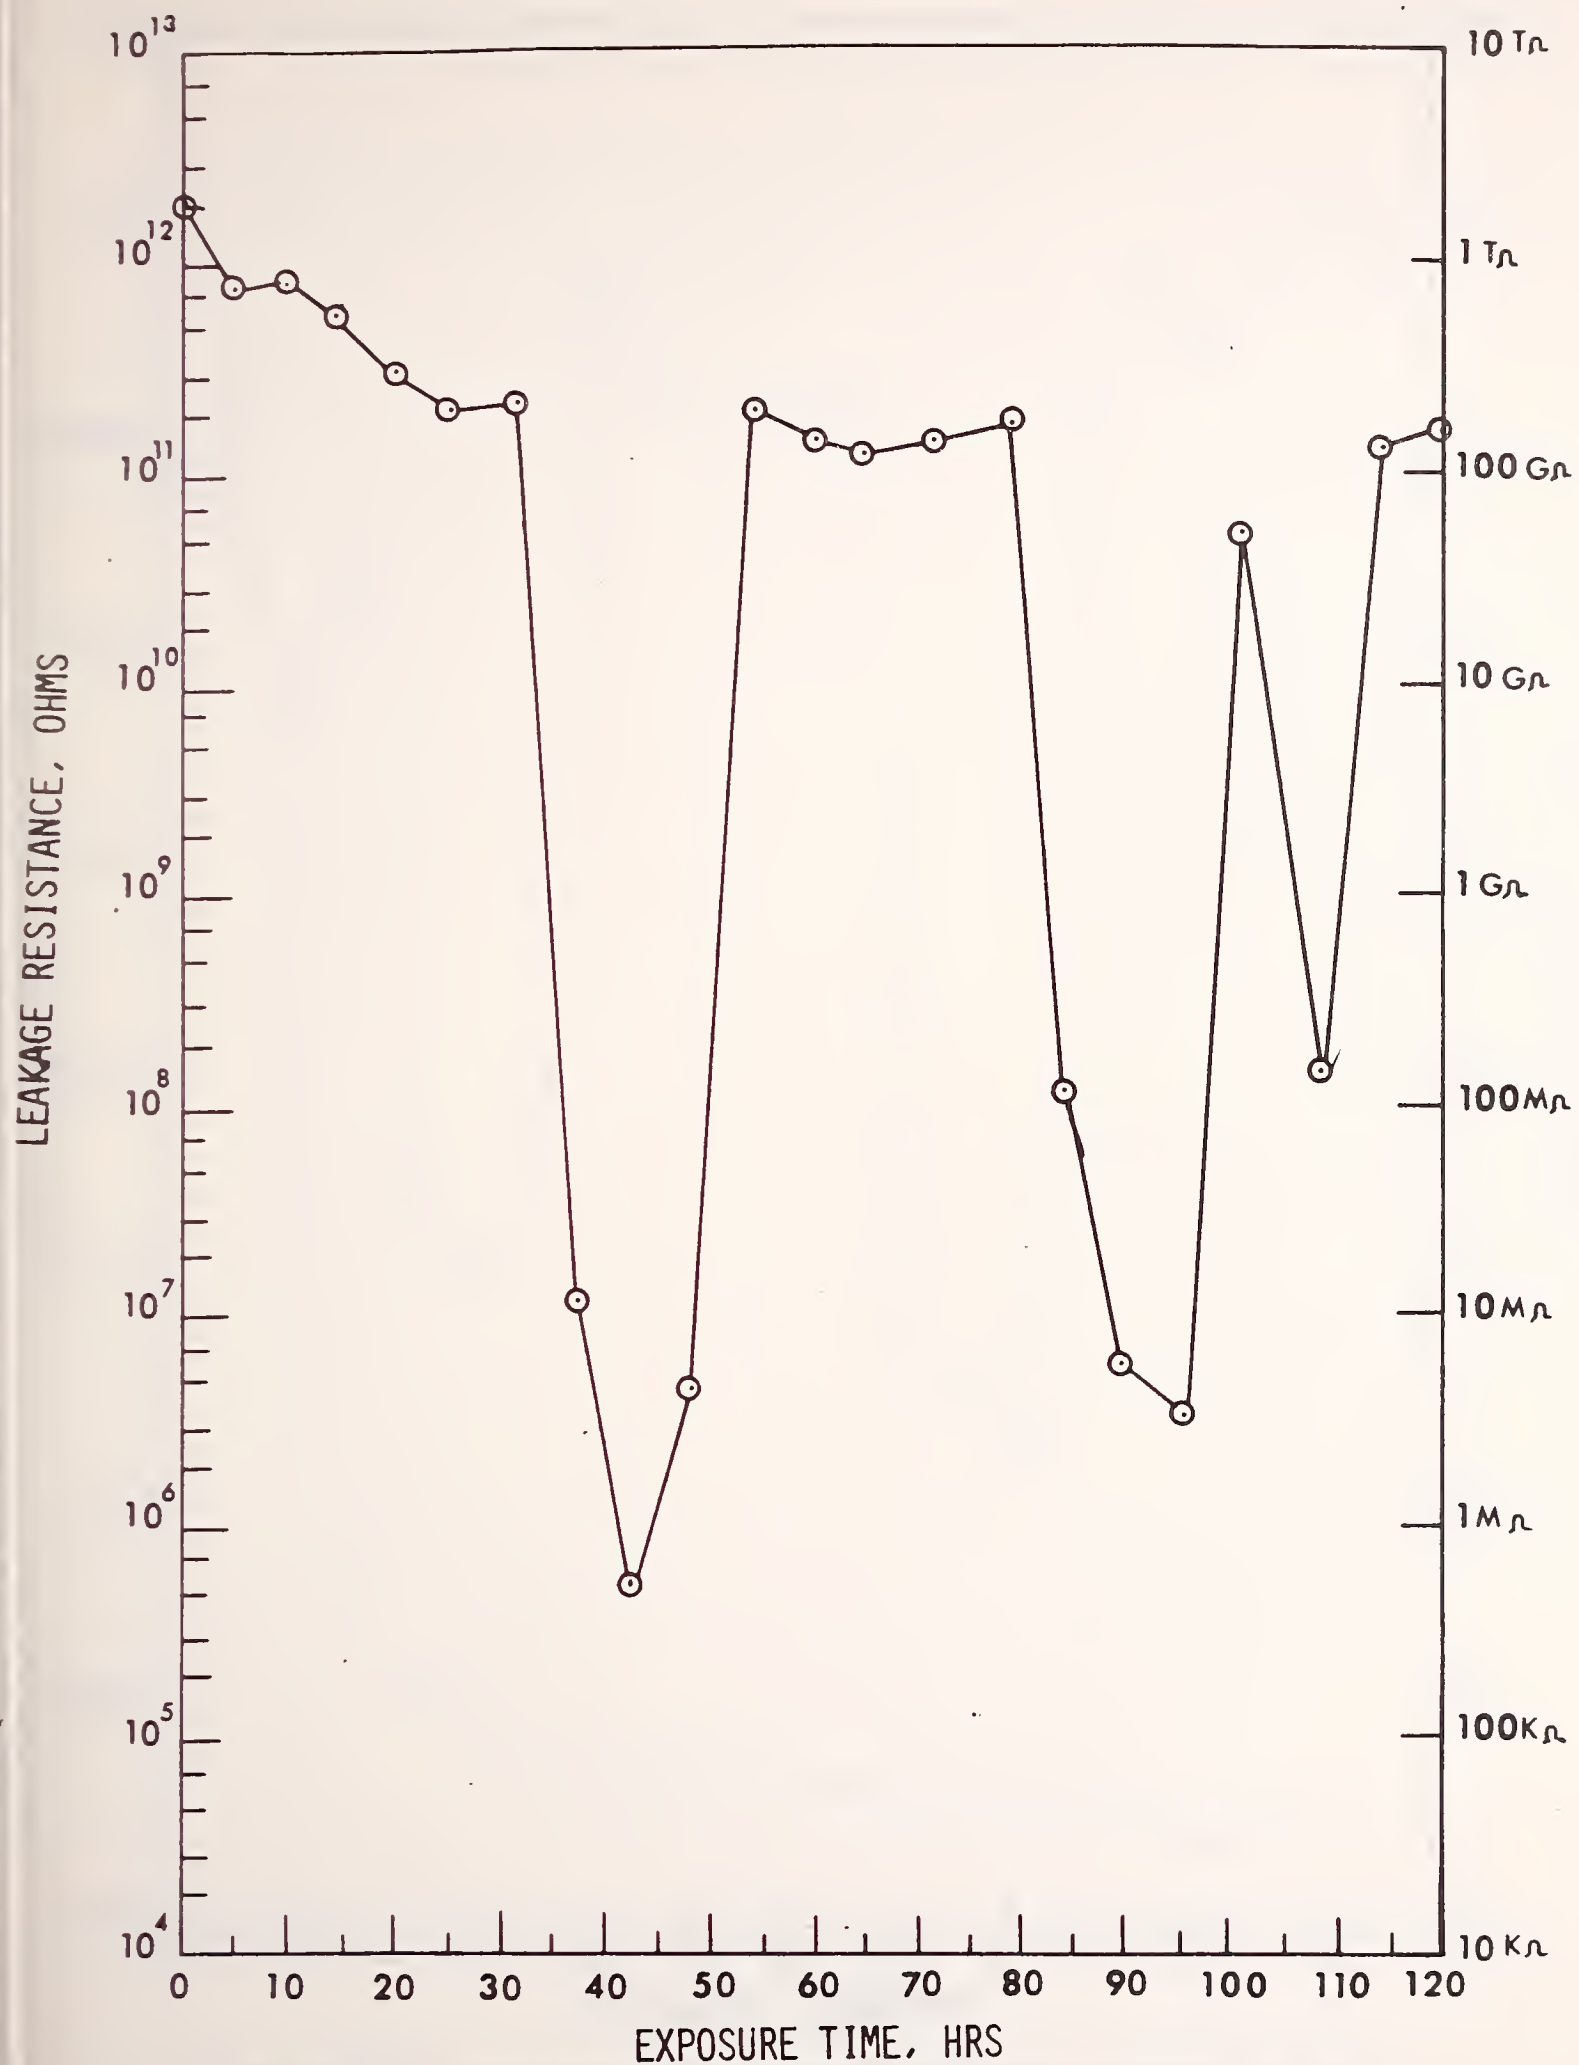
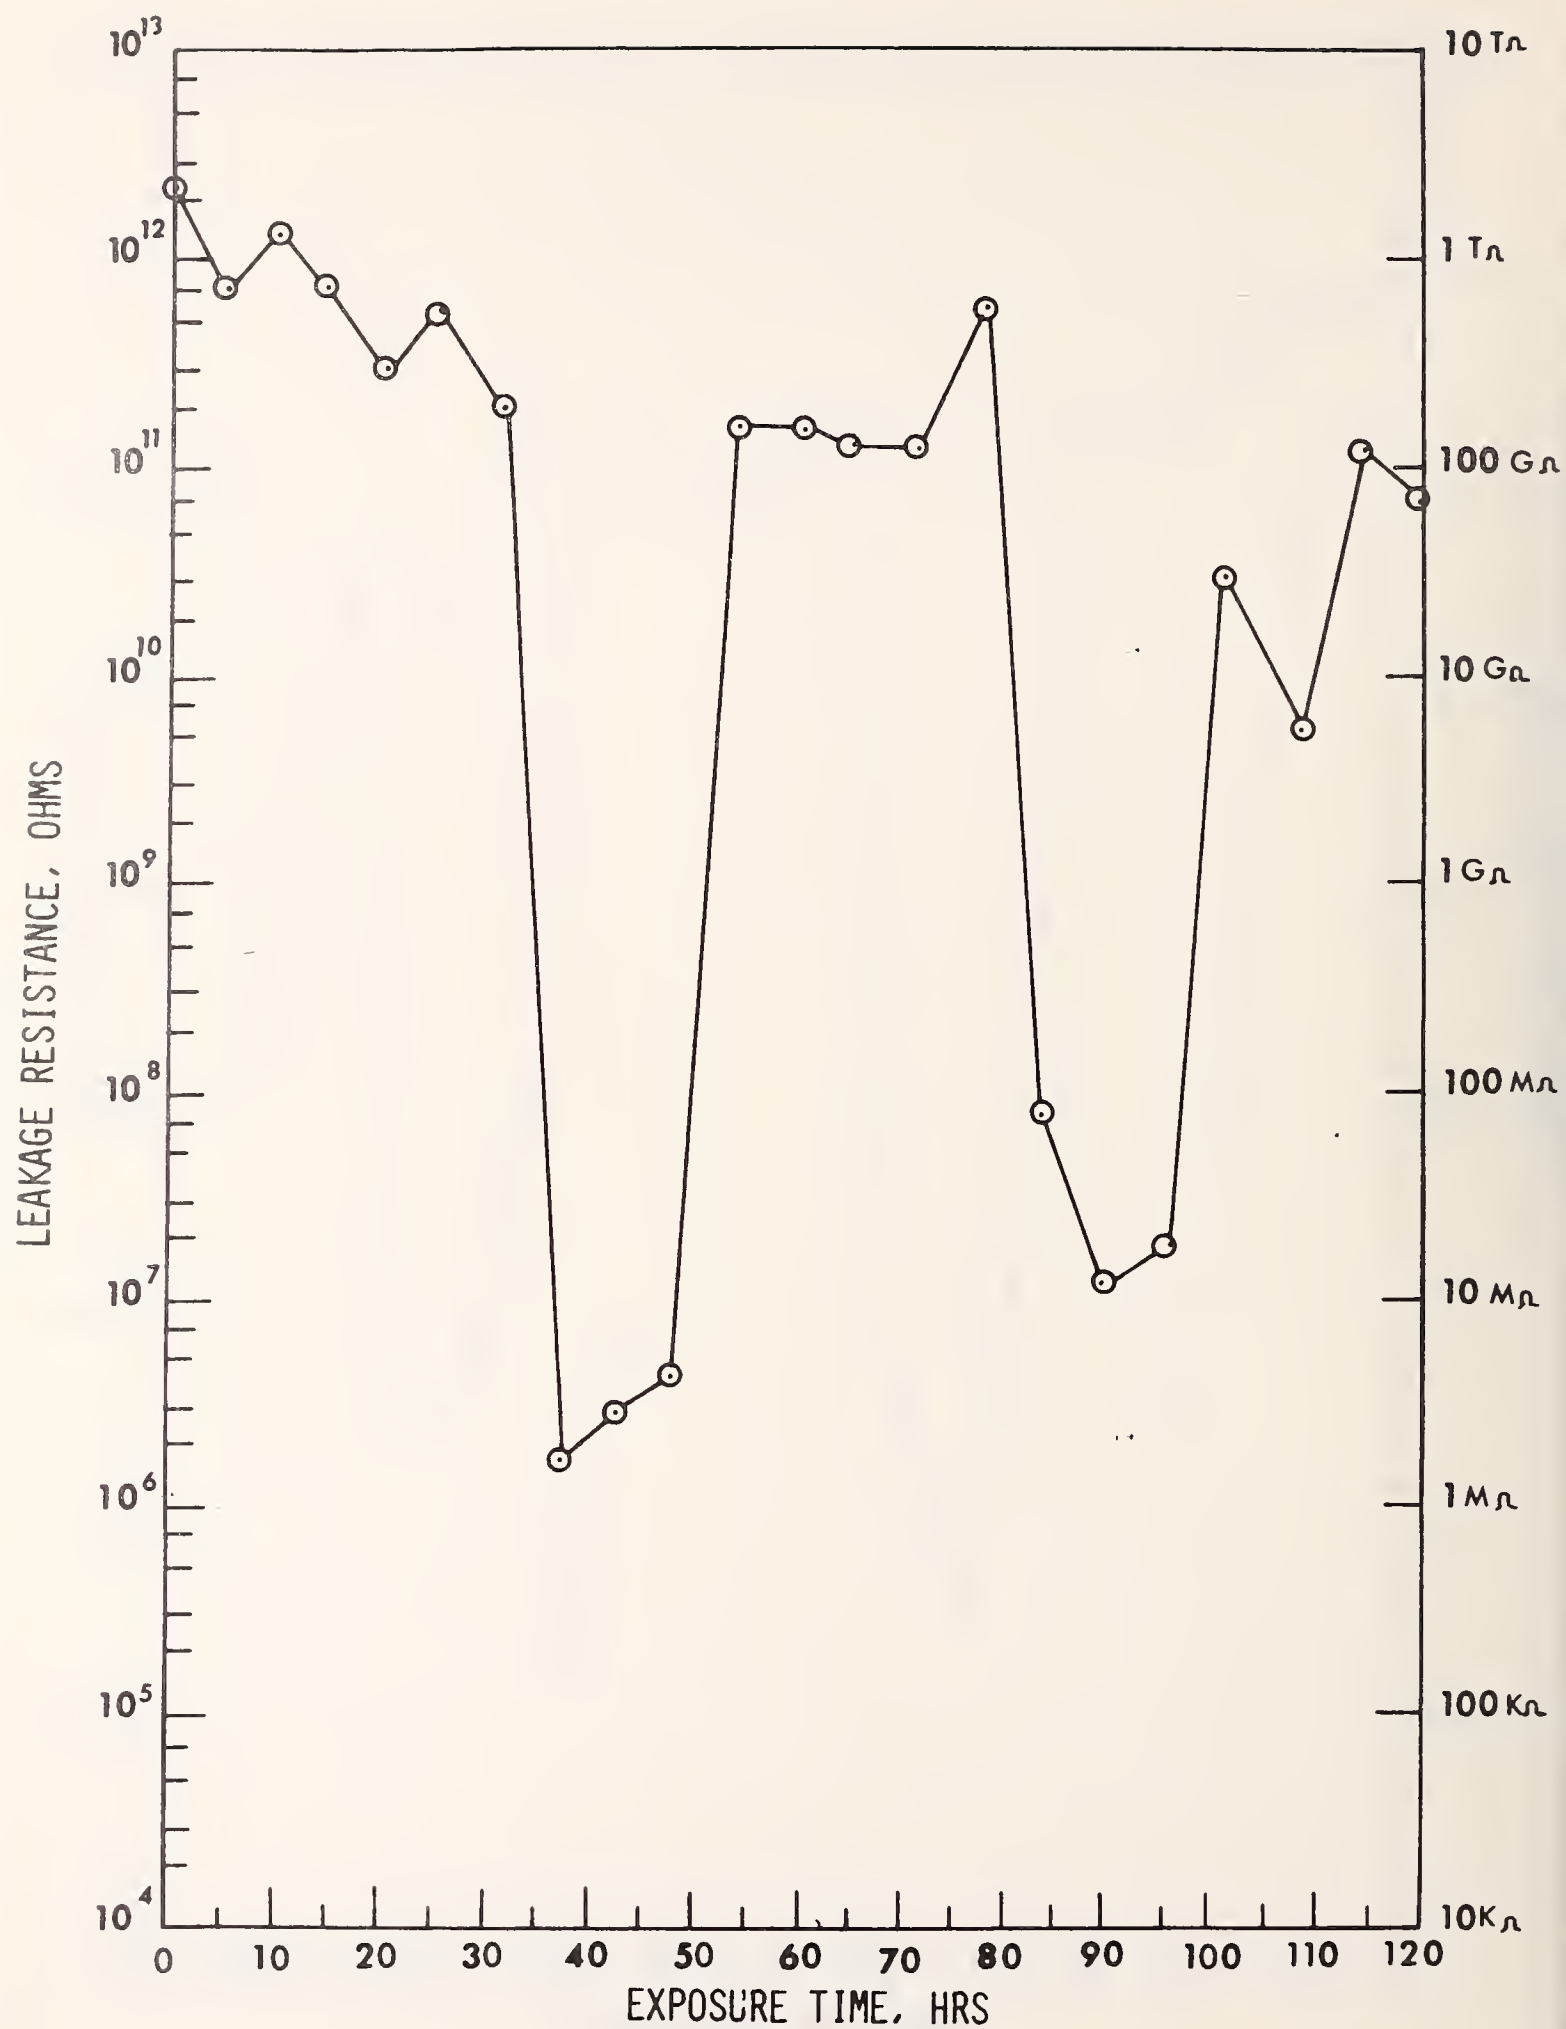
Figure 3a. Electrical leakage resistance for round transducer No. 1.

Figure 3b. Electrical leakage resistance for round transducer No. 2.

Figure 3c. Electrical leakage resistance for round transducer No. 3.

Figure 3d. Electrical leakage resistance for round transducer No. 4.

Figure 3e. Electrical leakage resistance for round transducer No. 5.

Figure 3g. Electrical leakage resistance for round transducer No. 7.

The initial leakage resistances of the round transducers were about 2 T Ω . In most instances, they decreased to about 0.1 T Ω towards the end of the test. Examination of the plotted data in Figures 3a through 3g and of the data given in Table 1 shows an unusual decrease in resistance over the exposure period from about 37 hours to 54 hours,

and another decreased resistance from about 84 hours to 102 hours. These decreases were caused by periods of rain prior to and during the time the resistance measurements were taken. Appendix A gives relative humidity and rainfall data for the test period. A high degree of correlation exists between periods of high humidity and rain and the lower measured leakage resistances. It is felt that the active portion of the transducer was not affected by the rain, but rather the leads and the terminals where the megohm bridge was connected were sensitive to atmospheric moisture. This effect and the resulting decrease of resistance during rainy periods cannot be considered as normal transducer characteristics because these transducers had different terminations than those used in normal service.

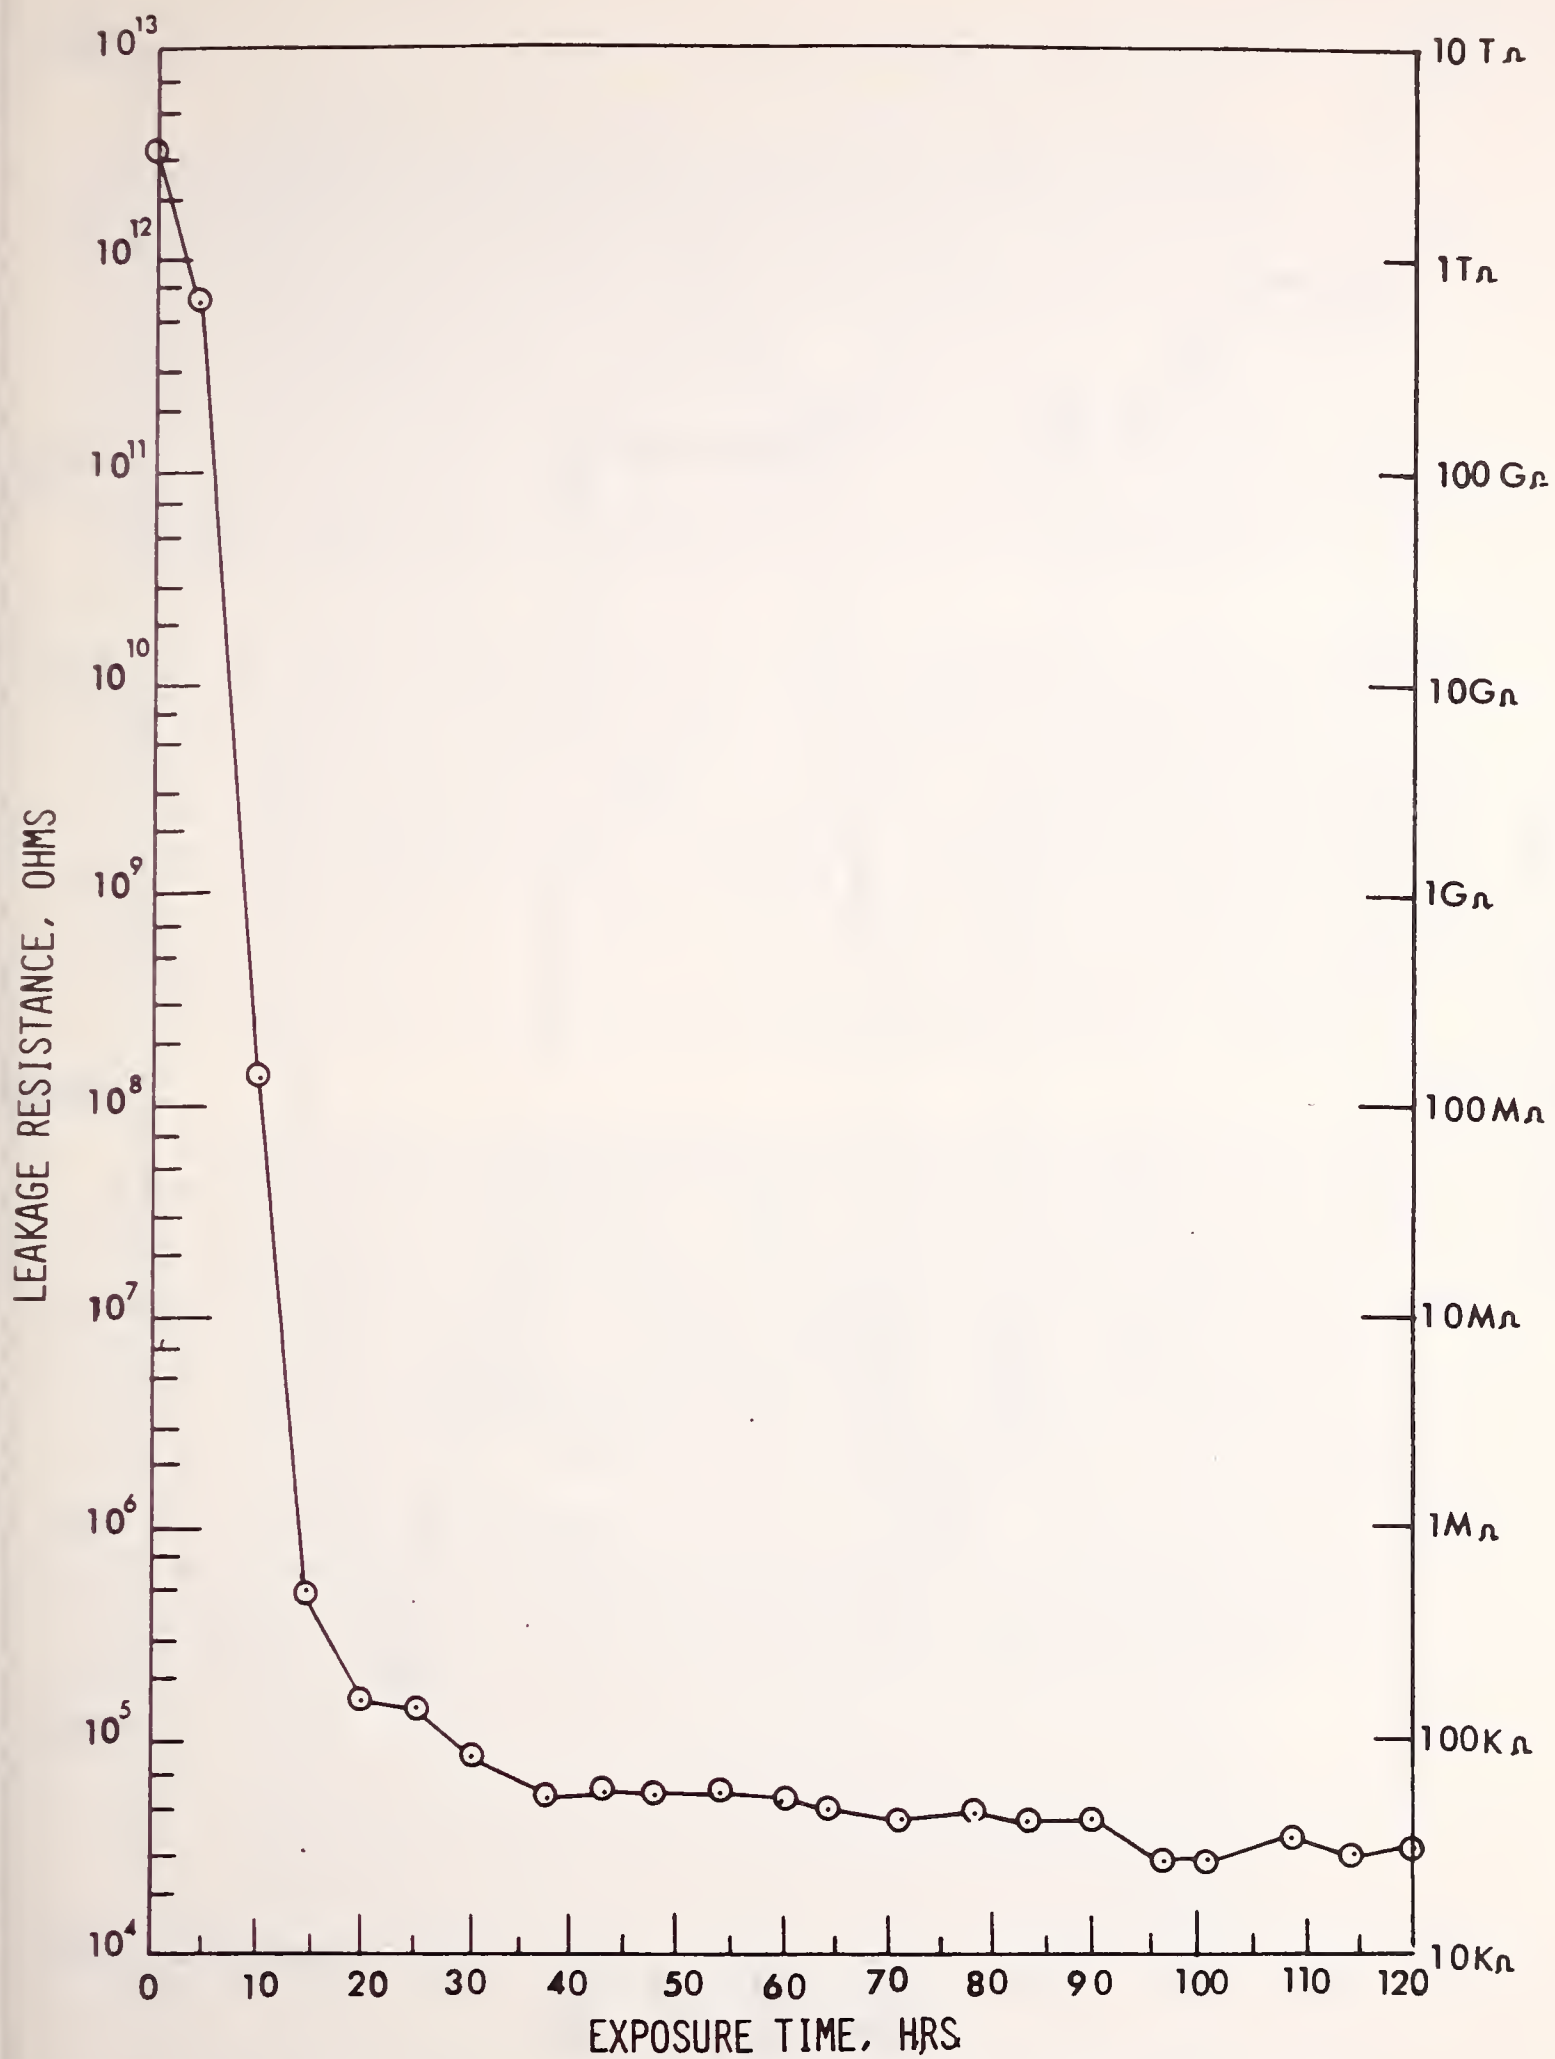
Figure 3f. Electrical leakage resistance for round transducer No. 6.

If the lower readings caused by rain are ignored, then the leakage resistance appears better behaved and generally remained high during most of the 120-hour exposure time. One notable exception exists, namely, transducer No. 6. Figure 3f and Table 1 show that the resistance decreased rapidly from the onset of testing. The resistance was measured at less than 100 k Ω over most of the test. Examination of this transducer after removal from the tank showed a gash in the outer polyurethane jacket which allowed large amounts of saline solution to enter the transducer. No other transducers exhibited the same kinds of characteristics during the test period. It is, therefore, concluded that none of the other round transducers had serious leaks and hence, did not fail.

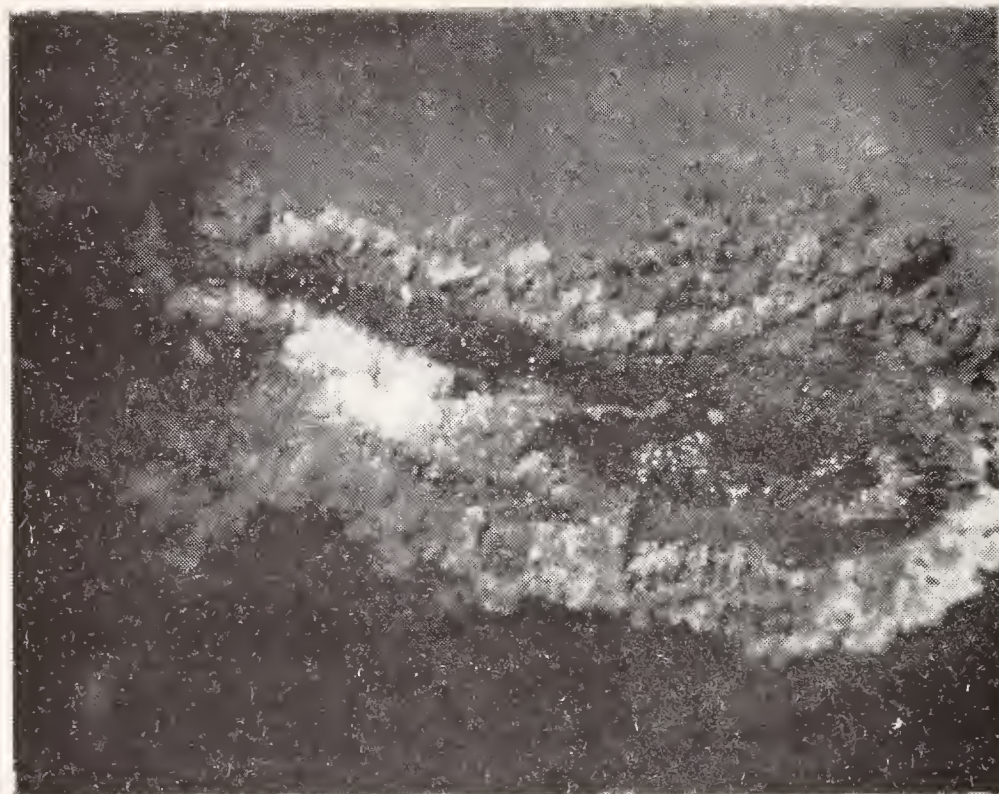
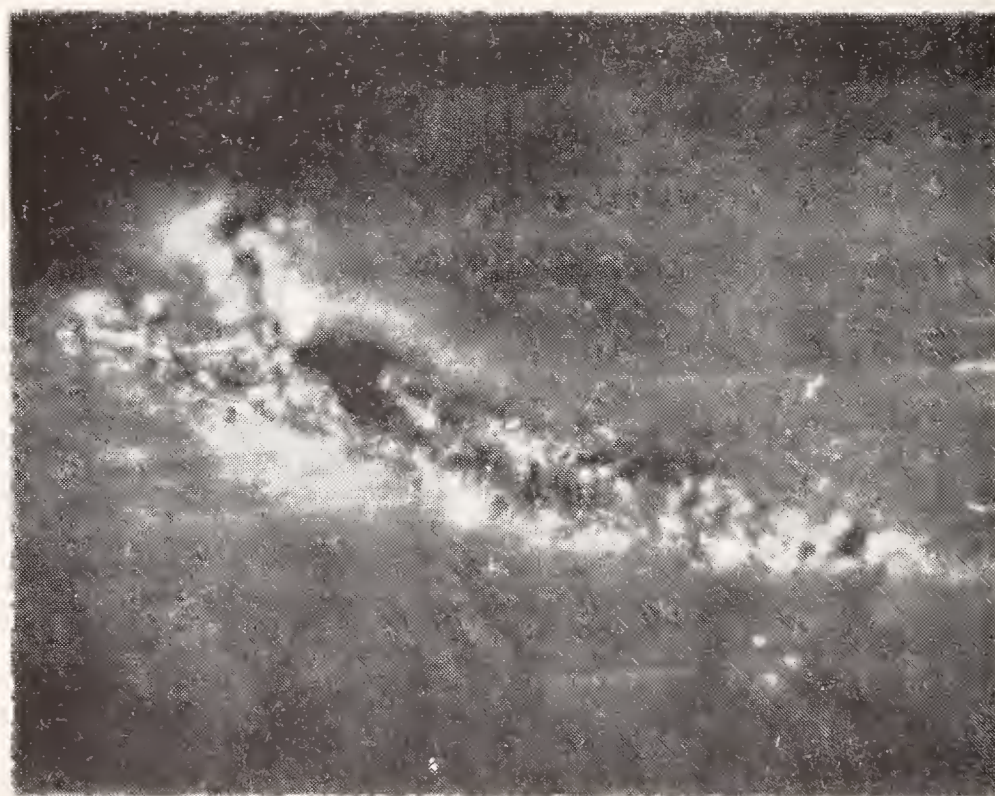
Figure 4a. Gash in polyurethane jacket of round transducer No. 6 prior to washing salt from transducer.

Figure 4b. Gash in polyurethane jacket of round transducer No. 6 after washing salt from transducer.

The gash found in round transducer No. 6 is believed to have been caused by the steam feed line. Early in the testing program, it was noted that the feed line flailed inside the tank and repositioned itself. It is possible that the flailing steam line could have slashed this transducer jacket, causing the damage. Microscopic examination shows definite signs of cutting, and not tearing as might occur as a result of a pressurized rupture. Figure 4 shows the damaged polyurethane jacket. After removing the outer jacket, discolorations inside indicated that the solution had "traveled" the entire 2-m length of the transducer.

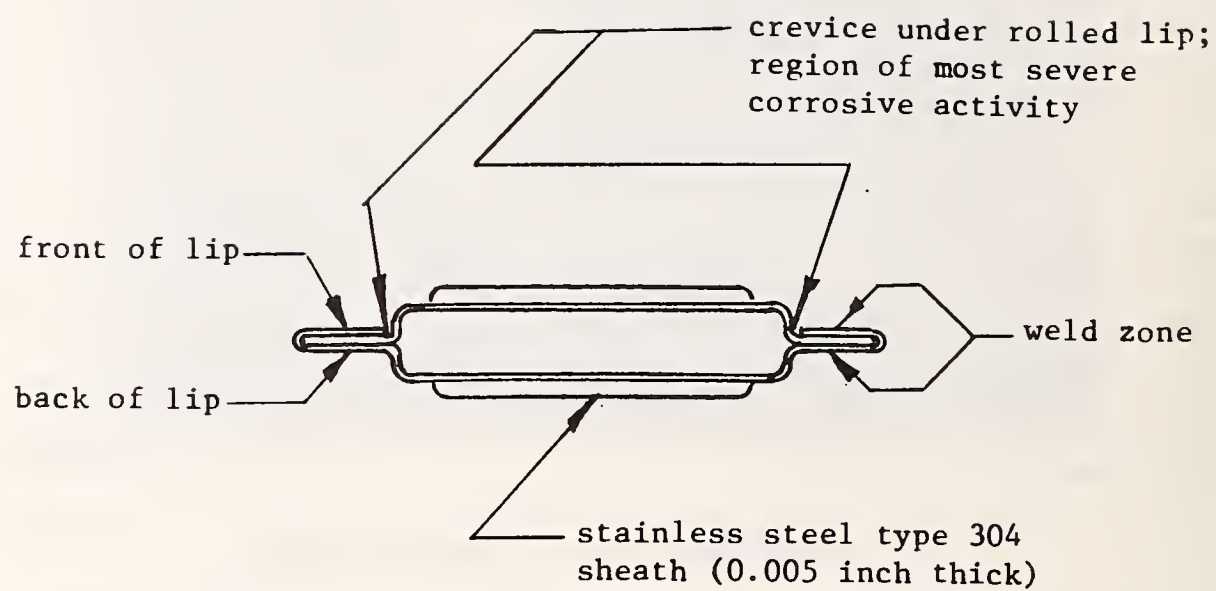
Figure 5. Cross section of a flat transducer showing region of most severe corrosion activity.

The flat stainless steel transducers which were tested in the saline solution all showed signs of corrosion. The most serious corrosive activity was localized in the region of the weld zone on the edges of the transducers. Figure 5 shows a cross section of the transducer sheath and indicates the region of most severe activity.

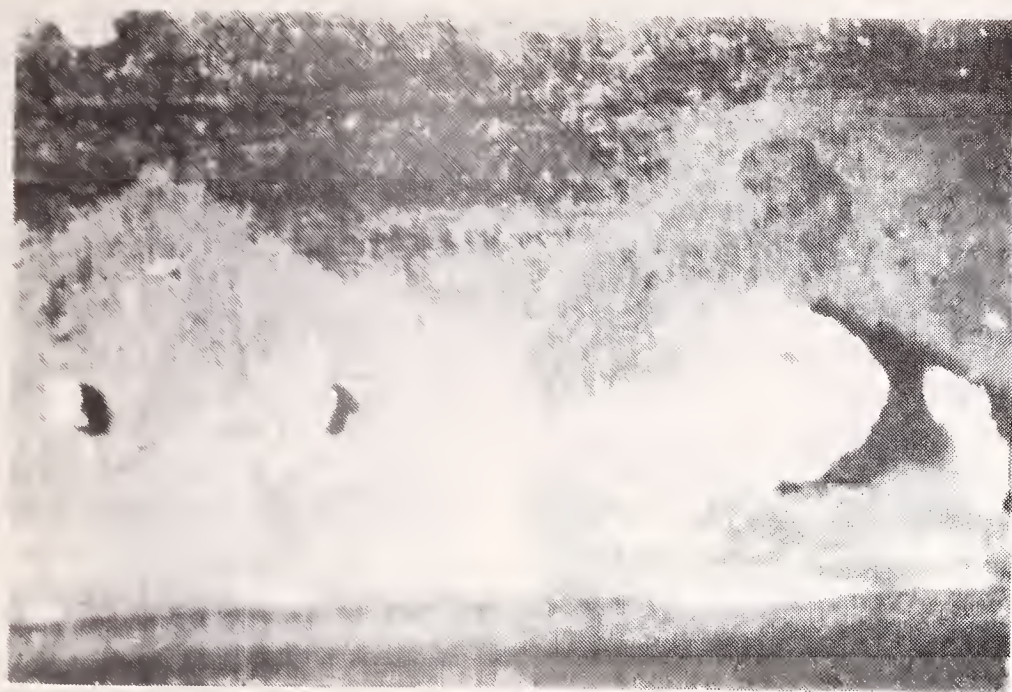
Figure 9. "Salt domes" and "whisker" on back of lip, transducer 7B, location 74 (20x magnification).
